Milton Park Local Development Order 2022: Biodiversity Strategy

Milton Park, Oxfordshire
17th March 2022

TG Report No. 14122_R01d_HM_NC

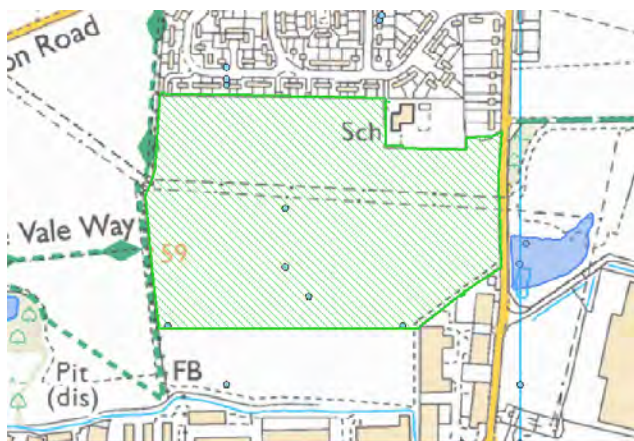
Figure 2: Lowland meadow priority habitat and pLWS boundary adjacent to the site boundary.

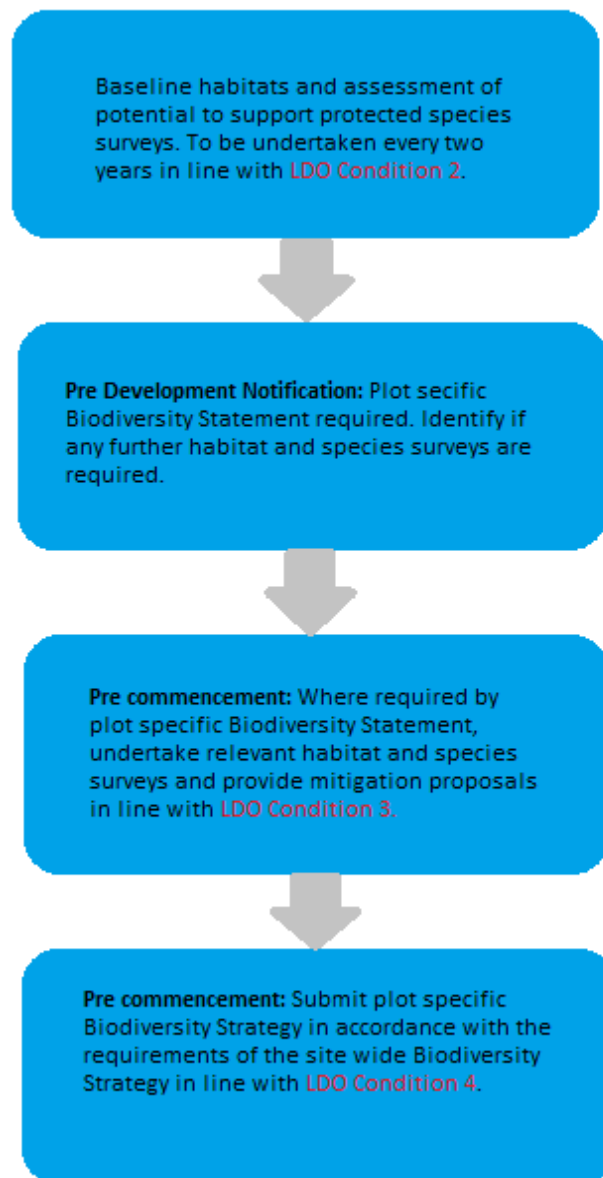
Figure 3: Flow chart detailing steps in the Biodiversity Strategy.

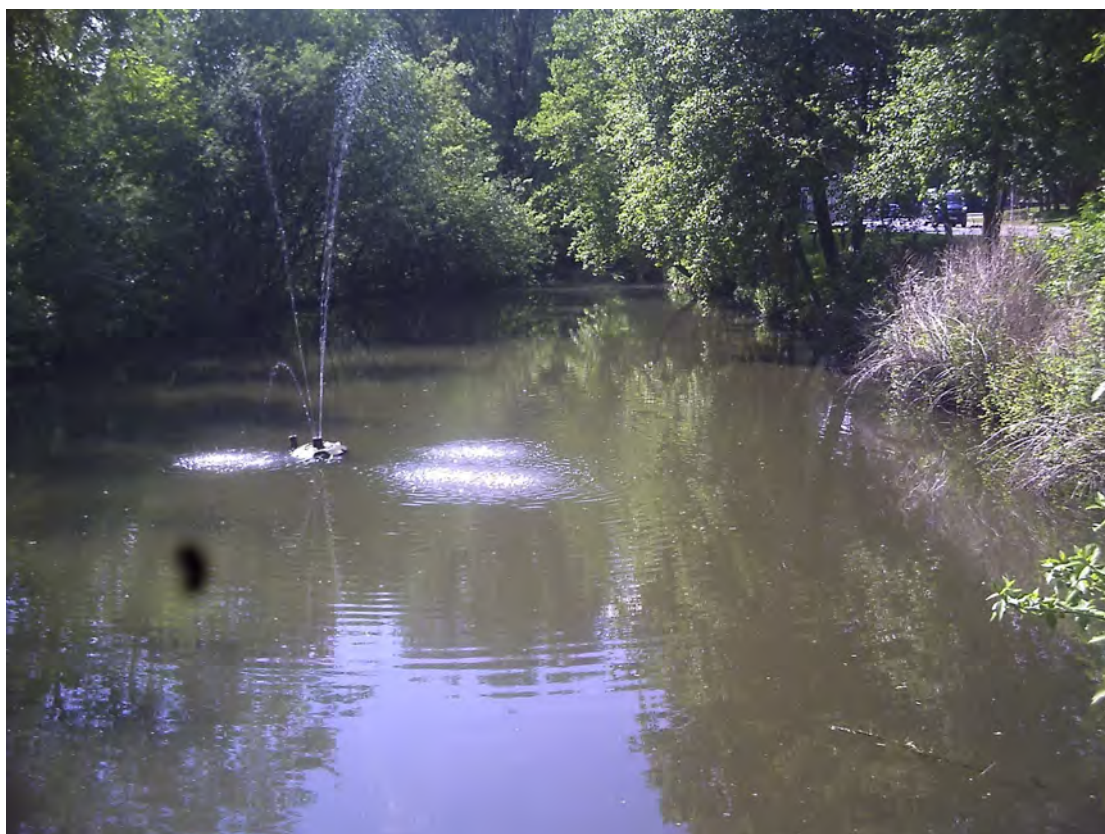
PHOTO 1 - LAGOON 1 - MAY 2020

Pool 1 (Figure 1A) is lined with trees on its south, east and western sides - at the top of the banks. These trees include Crack Willow *Salix fragilis*, Weeping Willow *Salix babylonica*, Goat Willow *Salix caprea*, Alder *Alnus glutinosa*, Ash *Fraxinus excelsior*, Poplar *Populus sp*, Dogwood *Cornus sanguinea*, Hawthorn *Crataegus monogyna*, Hazel *Corylus avellana* and ornamental shrubs.

No change was noted in July 2014. On the 13th May 2016 when the pool was revisited de-silting had taken place quite recently with most marginal vegetation removed, although some limited areas of Sedges and Reedmace remained. There were otherwise no other changes apart from some limited removal of shrubs at the eastern end to facilitate access.

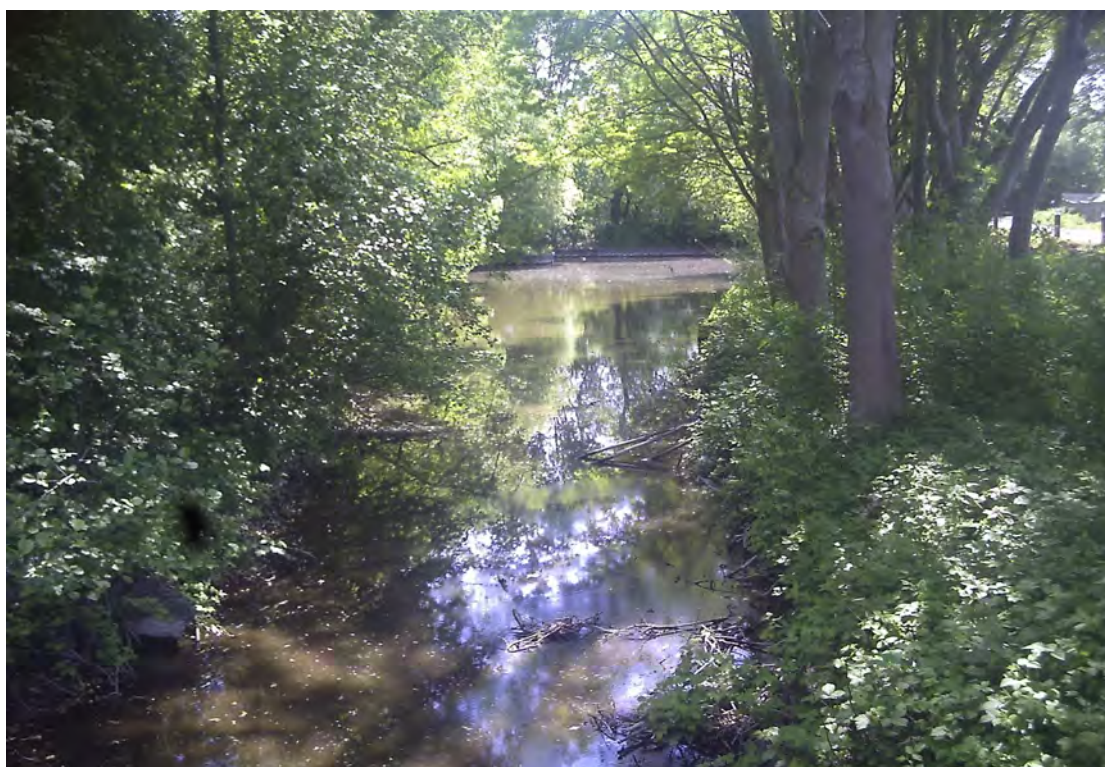
PHOTO 2 – LAGOON 2 – MAY 2020

Pool 2 is mainly surrounded by semi-mature trees, close to the waters edge, creating a more shaded habitat lacking in aquatic vegetation apart from a limited area of Sedges. The margins are gently sloping on the west bank and much steeper on the southern and eastern banks. This is the largest pool within Milton Park. Trees include Ash, Crack Willow and Goat Willow.

On the 13th of May 2016 the lagoon had been recently de-silted with one mid aged tree removed. Inevitably the de-silting operation had caused some limited damage to the west bank of the lagoon however reinstatement was planned with wild flower re-seeding.

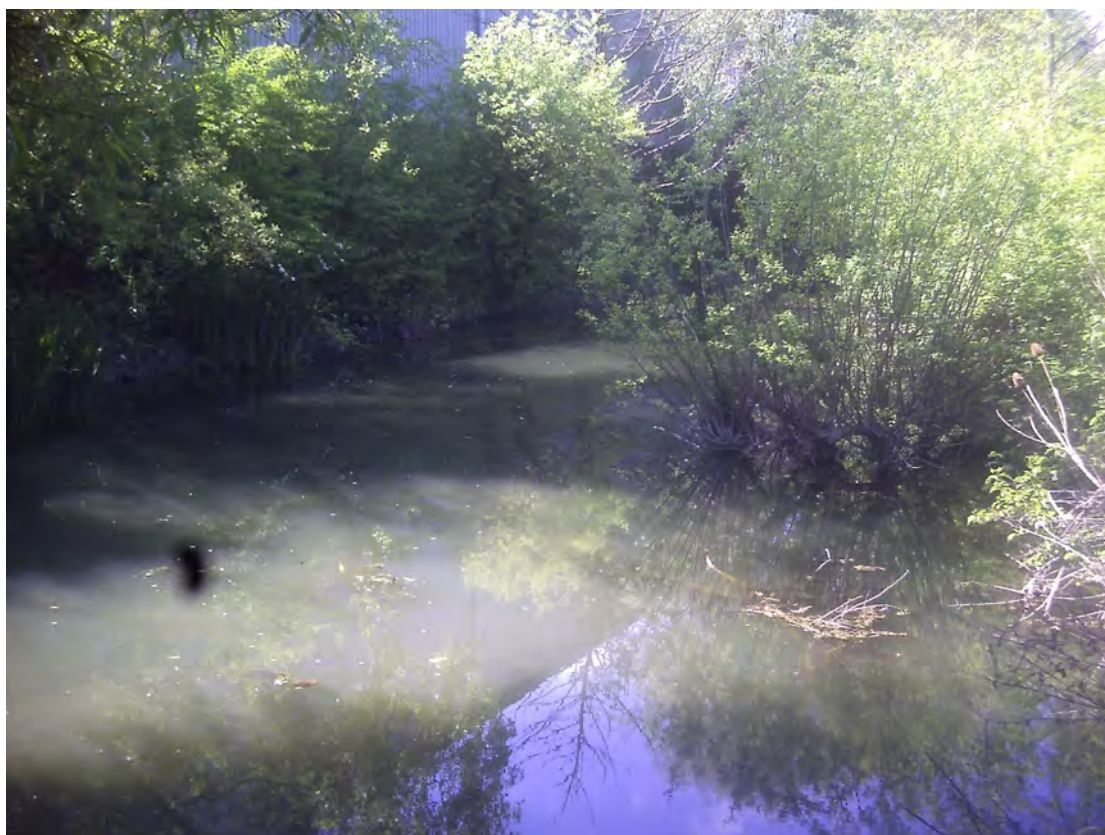
PHOTO 8 – LAGOON 6 – MAY 2020

Pool 6 consists mainly of open water. There is a limited area of Sedges and Hard Rush as well as some Yellow Flag Iris. A line of trees is present on the south and east side of the pool consisting of Silver Birch, Crack Willow, Goat Willow and Alder. This pool has quite steeply sloping sides.

In May 2018 the Crack Willows had been pollarded making the pool more open. No changes were observed when the pool was re-surveyed in May 2020.

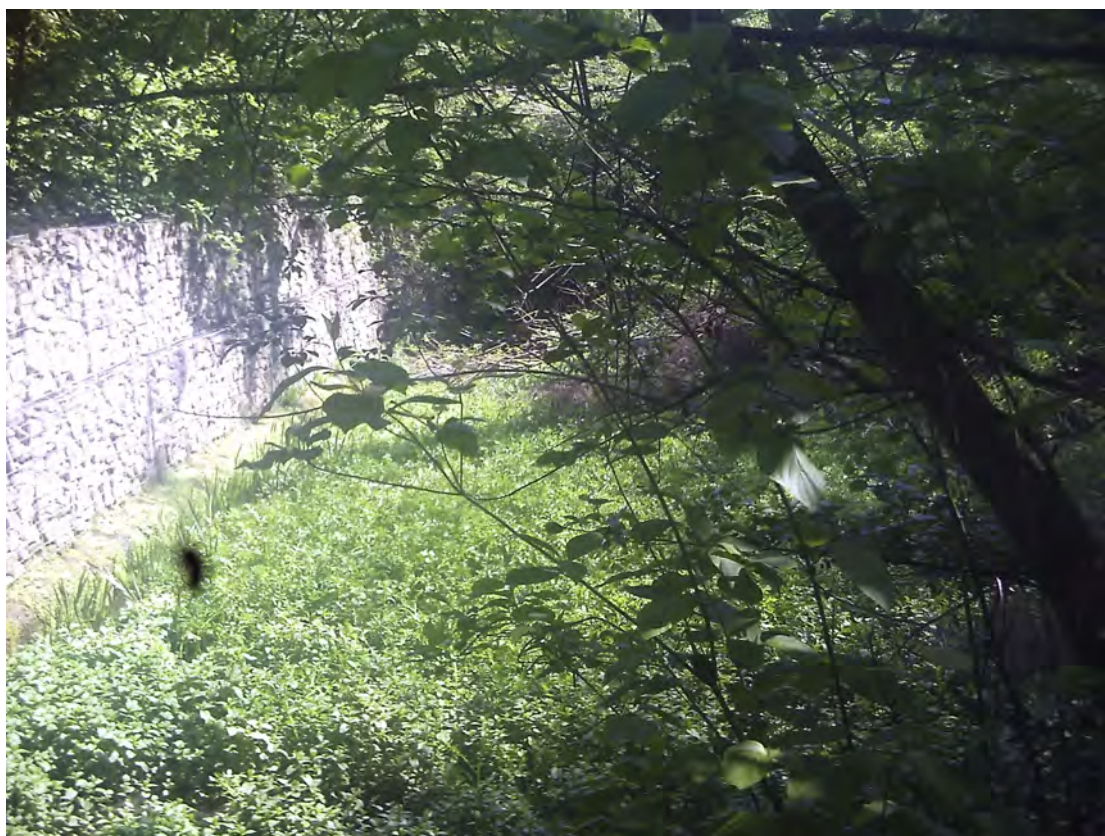
PHOTO 9 – LAGOON 7 - MAY 2020

Pool 7 is a shallow isolated pond in the south-east corner of the site. It was originally well vegetated with Reedmace and Watercress *Rorippa nasturtium-aquaticum*. There is Goat Willow scrub on the south side of the pool, which is otherwise open. The pool has very shallow sides on its south bank but the north bank is lined with gabion baskets, these were replaced in 2012 and the pool dredged so that it was lacking in vegetation in 2012.

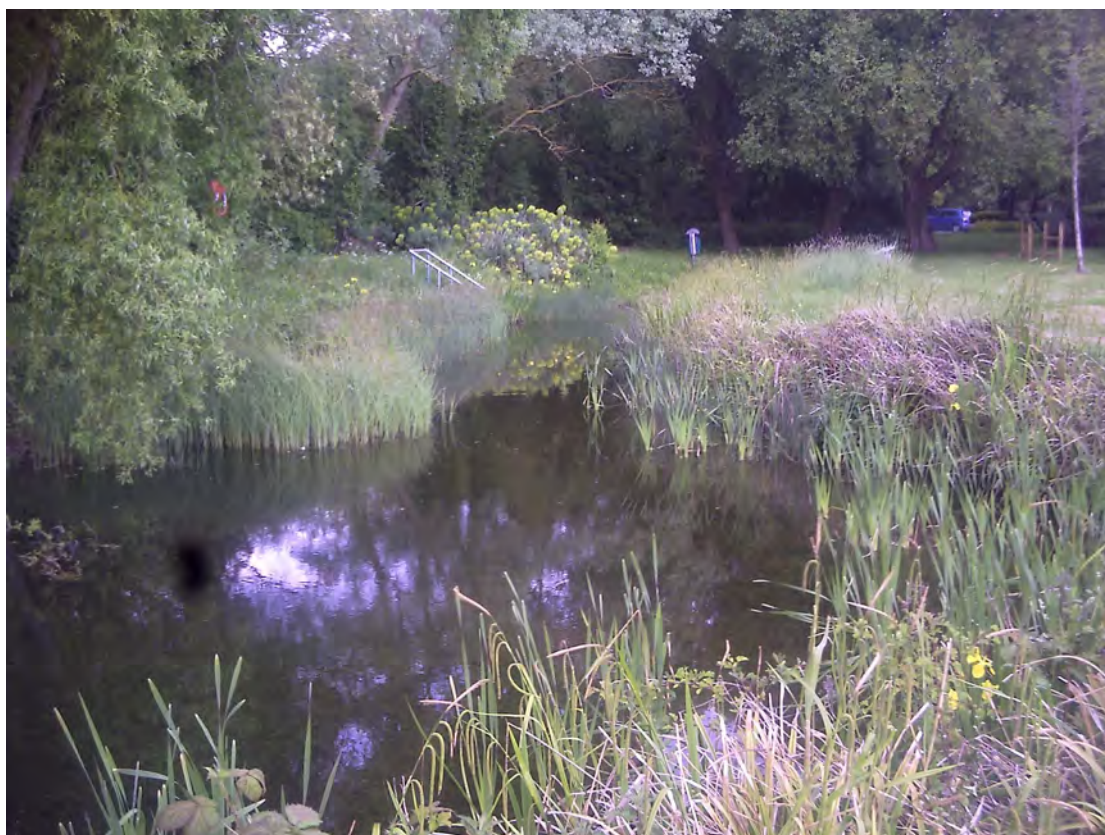
PHOTO 10 – LAGOON 8 – MAY 2020

Pool 8 is also shallow with very gently sloping margins. It is dominated by Reedmace, Yellow Flag Iris and there are also Sedges and Marsh Marigold *Caltha palustris* has also colonised. On the north side of the pool are Crack Willows and ornamental shrubs.

No particular changes was observed in June 2014, May 2016, May 2018 or May 2020.

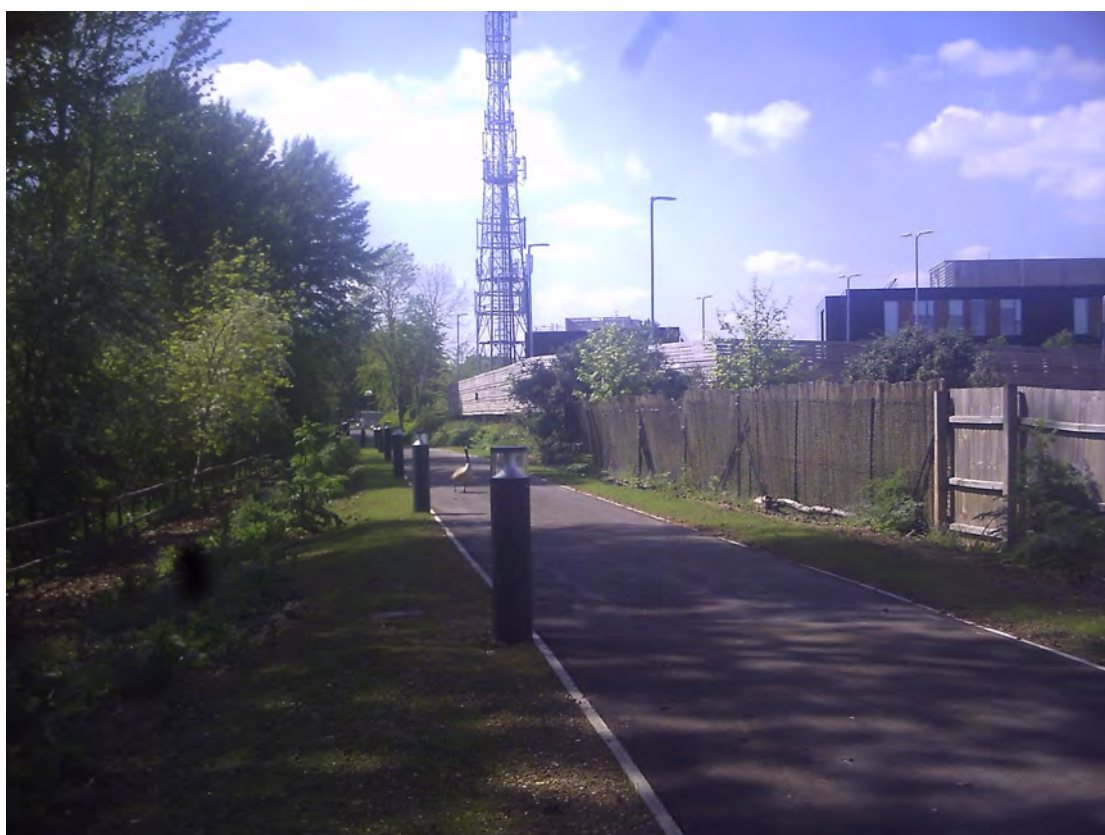
PHOTO 14 – STREAM CORRIDOR BETWEEN LAGOONS 1 & 2 – MAY 2020

No changes were noted as a result of the update surveys in 2014. However in May 2016 the stream corridor between Lagoons 1 and 2 had been de-silted and the Goat Willow, Dogwood and Snowberry scrub thinned. The Hawthorn, Aspen and other trees remained. Yellow flag Iris had started to colonise in the stream. Sedges were also apparent on May 2018.

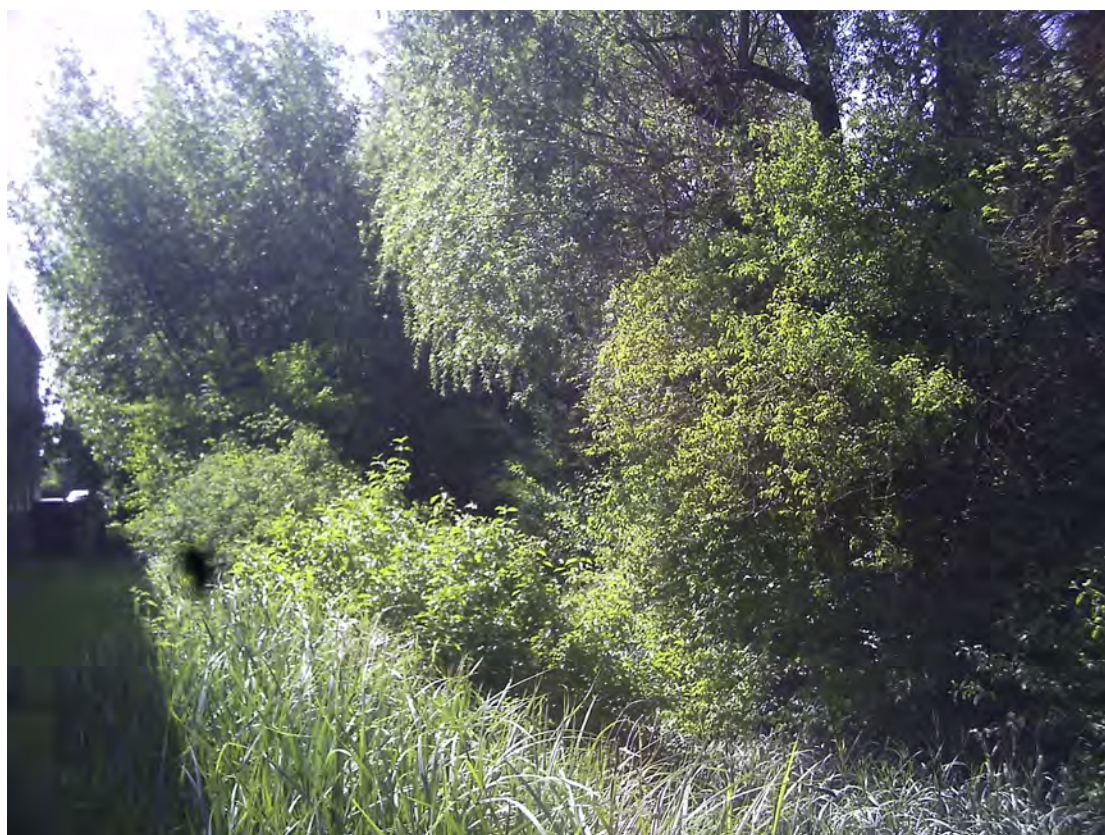
PHOTO 22 - SECTION OF DITCH SOUTH OF BROOK DRIVE - EAST END 2020

A short section of ditch exists to the south of Brook Drive in the north – east part of the site. This is well vegetated with sedges and Reedmace and has scrub on its northern bank including Crack Willow, Hawthorn, Dogwood and Elder. The section remained unchanged throughout the surveys (May 2016, May 2018 and May 2020).
