# CONTAMINATED LAND REMEDIATION STRATEGY AND VERIFICATION PLAN

Windmill Meadow  
Windmill Road  
Towersey  
OX9 3QQ

REM-2022-000017

STM Environmental Consultants Ltd

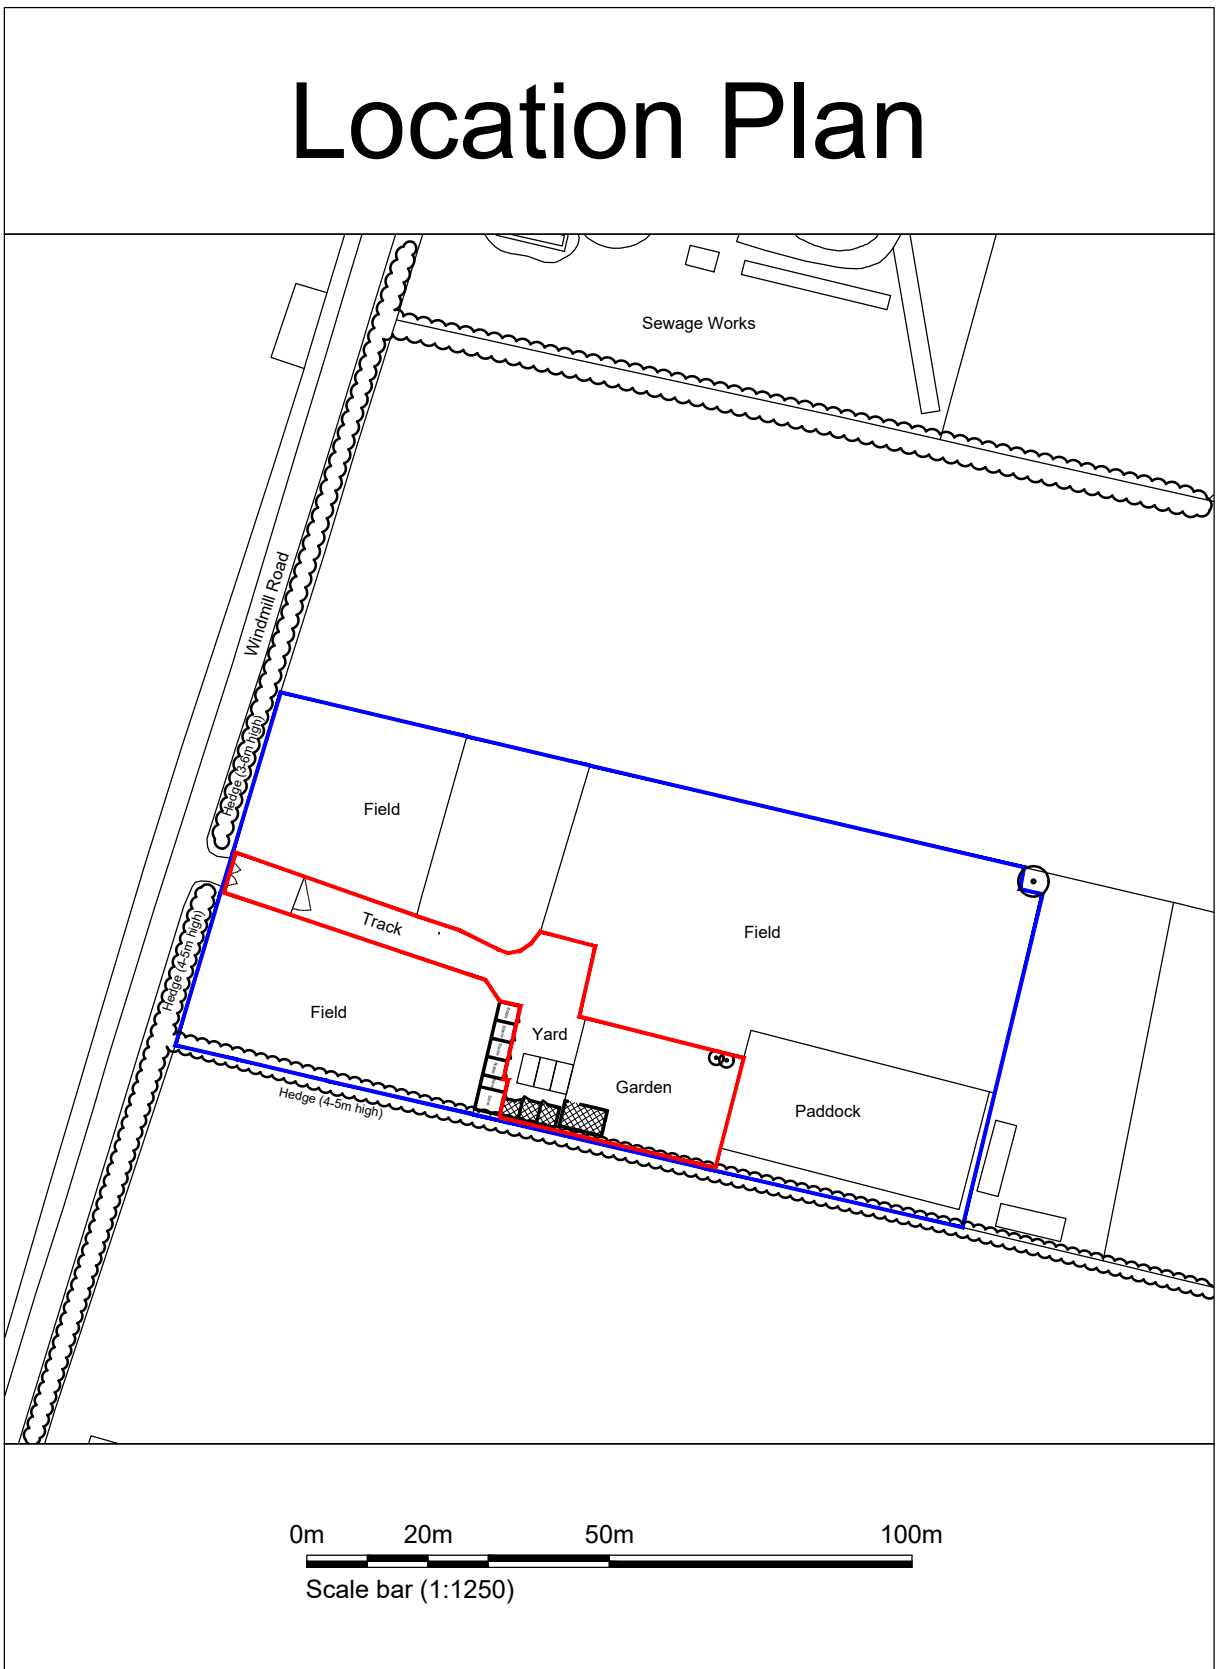
CLIENT:				Mrs Gillian Probets			
PROJECT:							
Windmill Meadow, Windmill Road, Towersey, Oxfordshire, OX9 3QQ							
TITLE: PROPOSED - Location and Site Plan							
PROJECT No:			DRAWING No:			ISSUE	
BHD-0055			P1			-	
STATUS:		Planning				SCALE: 1:200	
DRN:	N.H.	CHK:	--	DATE: Feb 2019		1:1250

Much of the area of the site will comprise driveways/car parking and the building footprint, and as such will encapsulated much of the contaminated made ground at the site. This means that it cannot be accessed via the direct contact pathway. This is shown in the proposed plans in [Appendix 2](#).
